SITE DECOMMISSIONING PLAN FOR THE CALTECH SUBMILLIMETER OBSERVATORY

TMK: (3) 4-4-015:009 (por.)

FEBRUARY 24, 2021

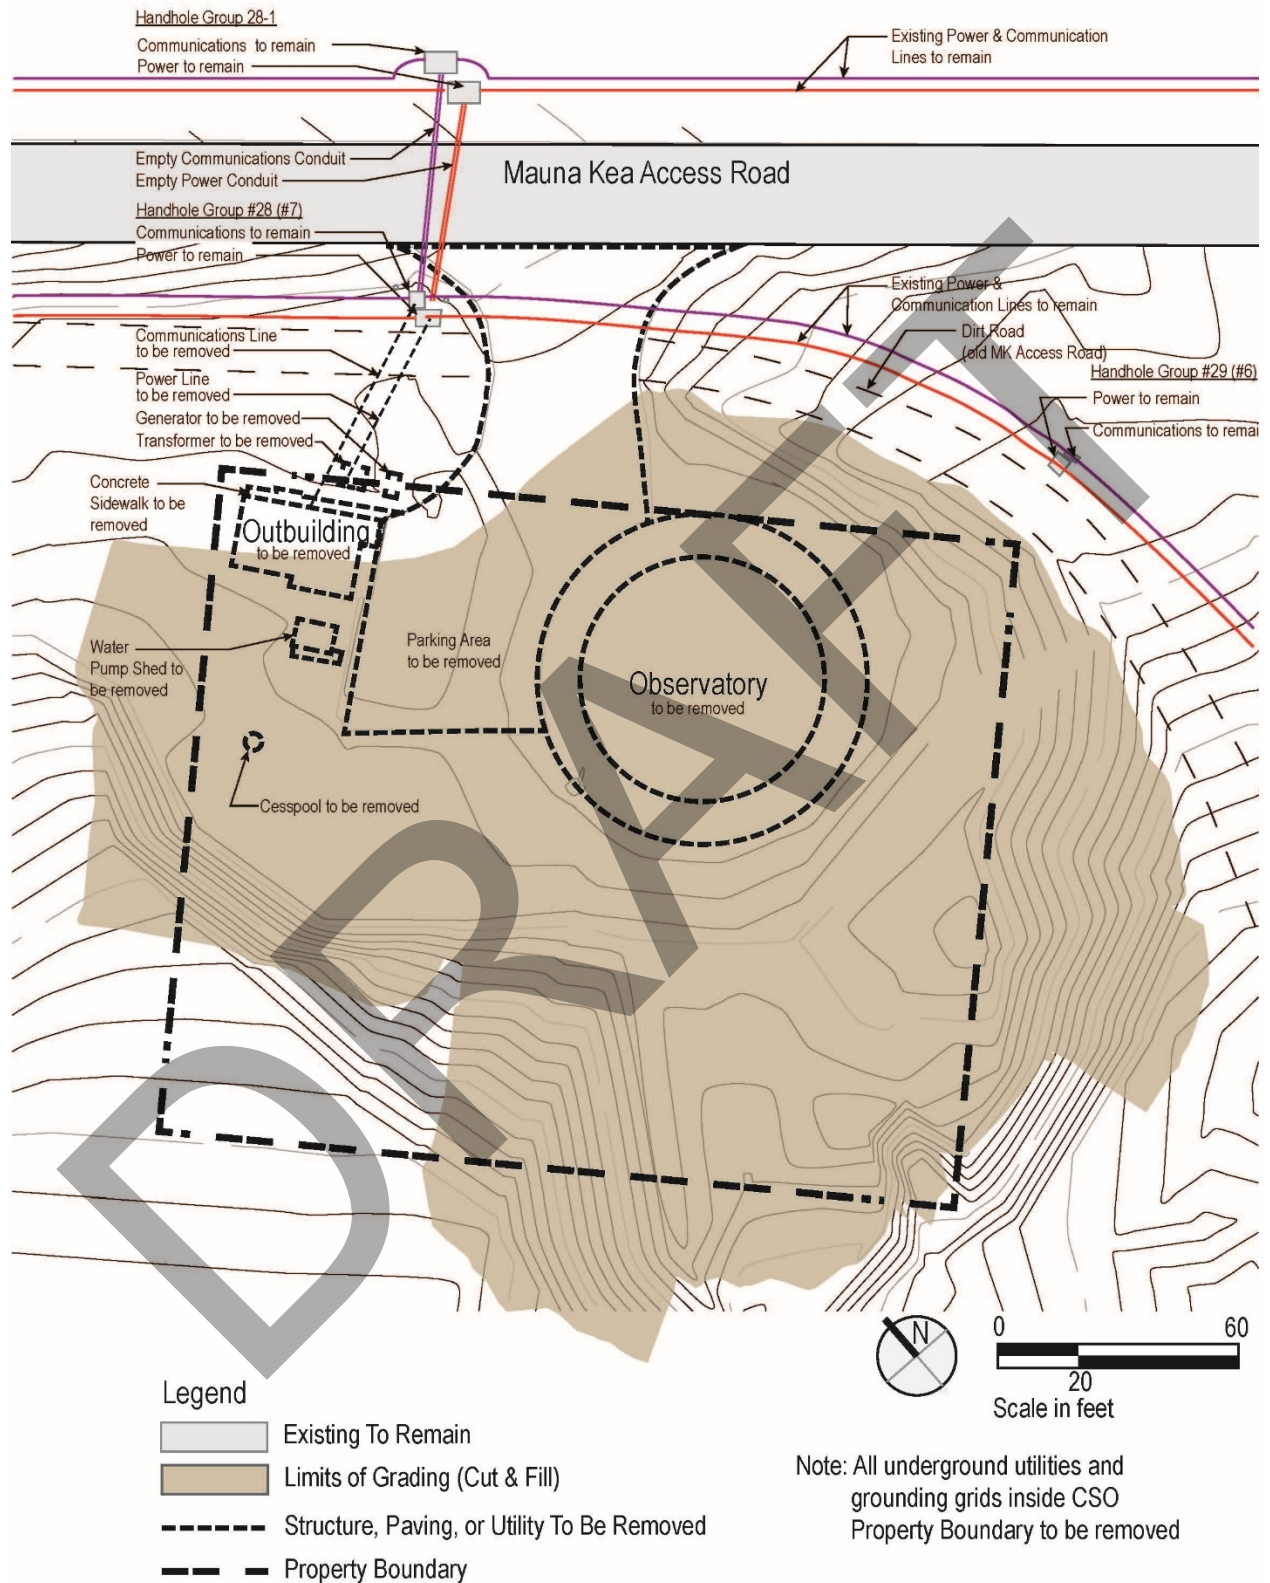
Figure 4-1: ALT-2 Scope of Work

Figure 4-1 illustrates the ALT-2 scope of work and Figure 4-2 illustrates anticipated site conditions following the implementation of the ALT-2 removal and restoration scope of work.

- The observatory and outbuilding foundations, cesspool, and other subsurface infrastructure on the CSO Site would be completely removed. The bulk of the subsurface infrastructure did not require excavation into the existing lava flow during construction. That infrastructure, and the fill around it, can be readily removed. There are locations where excavation into the lava flow took place during CSO construction, for example, the cesspool. The cesspool and other infrastructure, and fill around them, where excavation into the lava flow occurred, can also be readily removed but doing so will create cavities that will be addressed in the restoration process.

- Site restoration, as follows, using the methods outlined in Chapter 6, the SRP:
 - The topography would be returned to its pre-construction condition to the greatest extent possible. This will be achieved by removing fill placed on the lava flow during construction to the greatest extent possible. Cavities in the lava flow, where excavation occurred during construction (e.g., the cesspool), will be filled with a portion of the fill placed on the lava flow during construction, which is native to Maunakea.

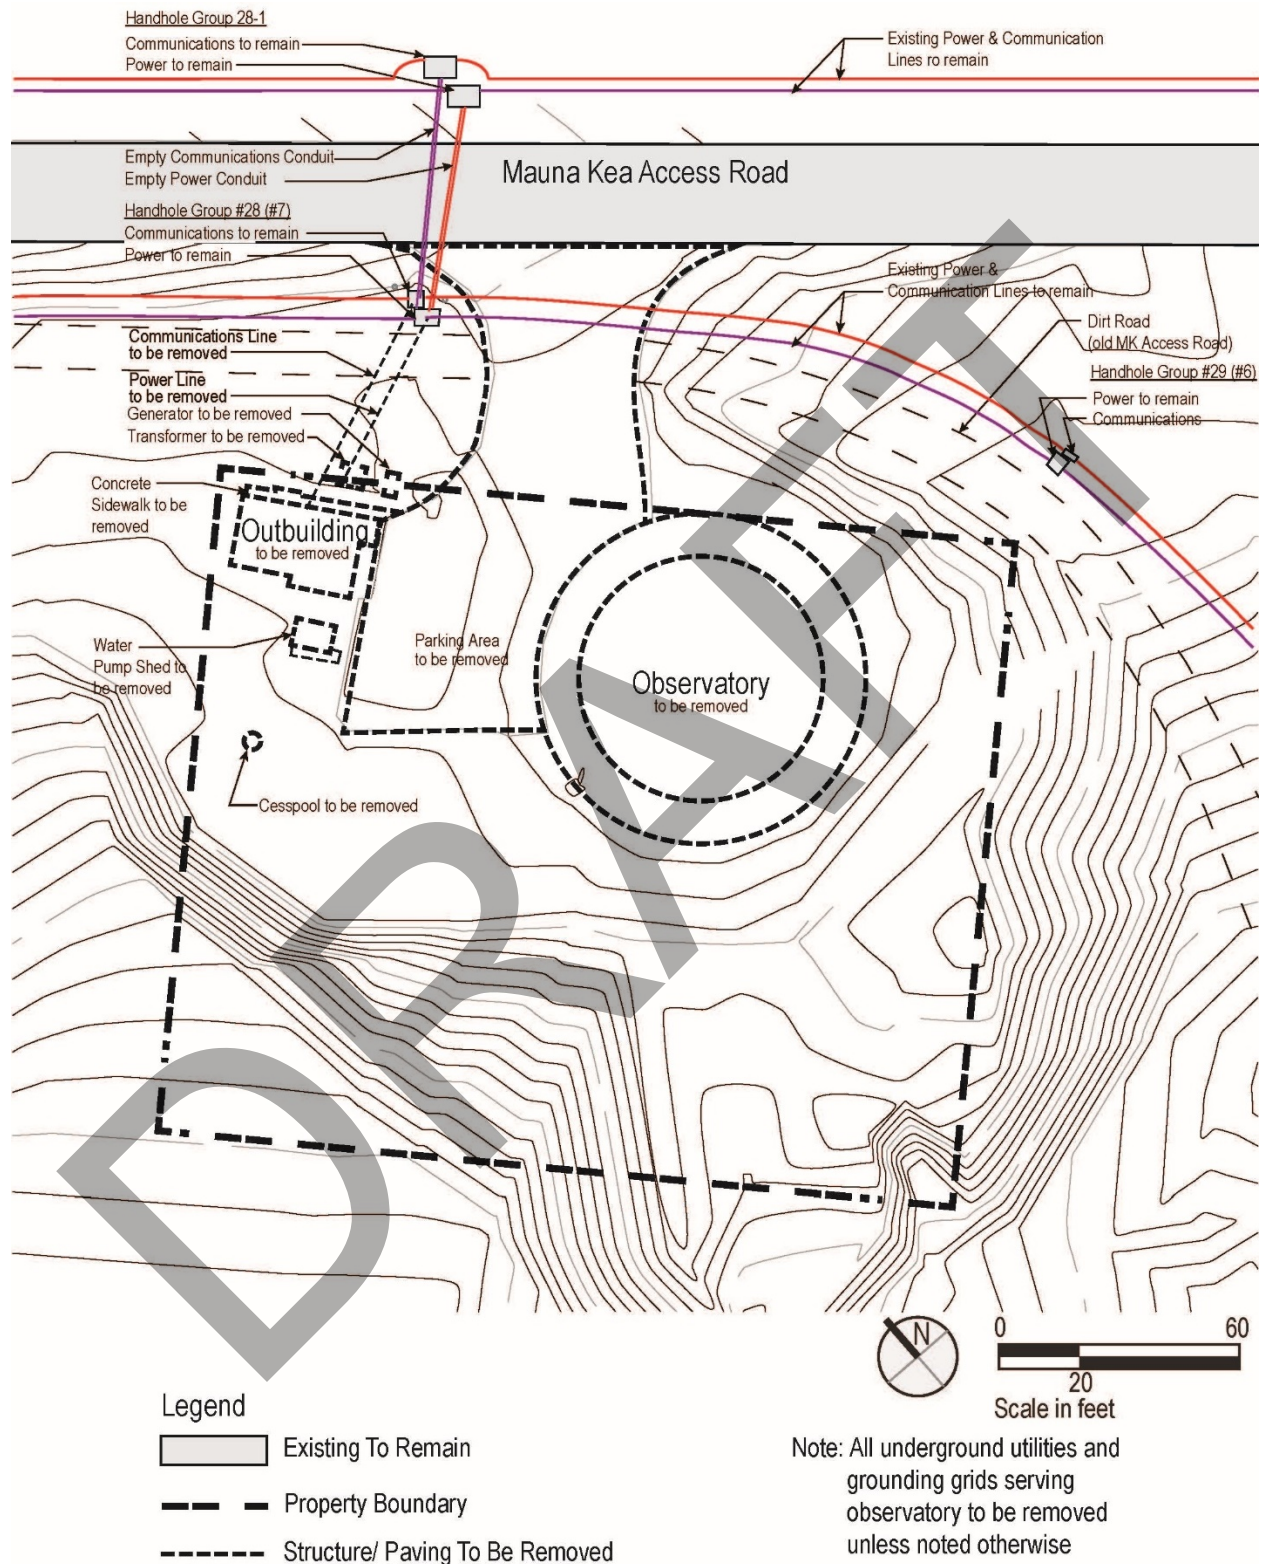
Figure 4-3: ALT-3 Scope of Work

Figure 4-3 illustrates the ALT-3 scope of work and Figure 4-4 illustrates anticipated site conditions following the implementation of the ALT-3 removal and restoration scope of work, which is that the CSO fill remains and topography is not restored (e.g., the highly unlikely, worst-case possibility under this alternative).

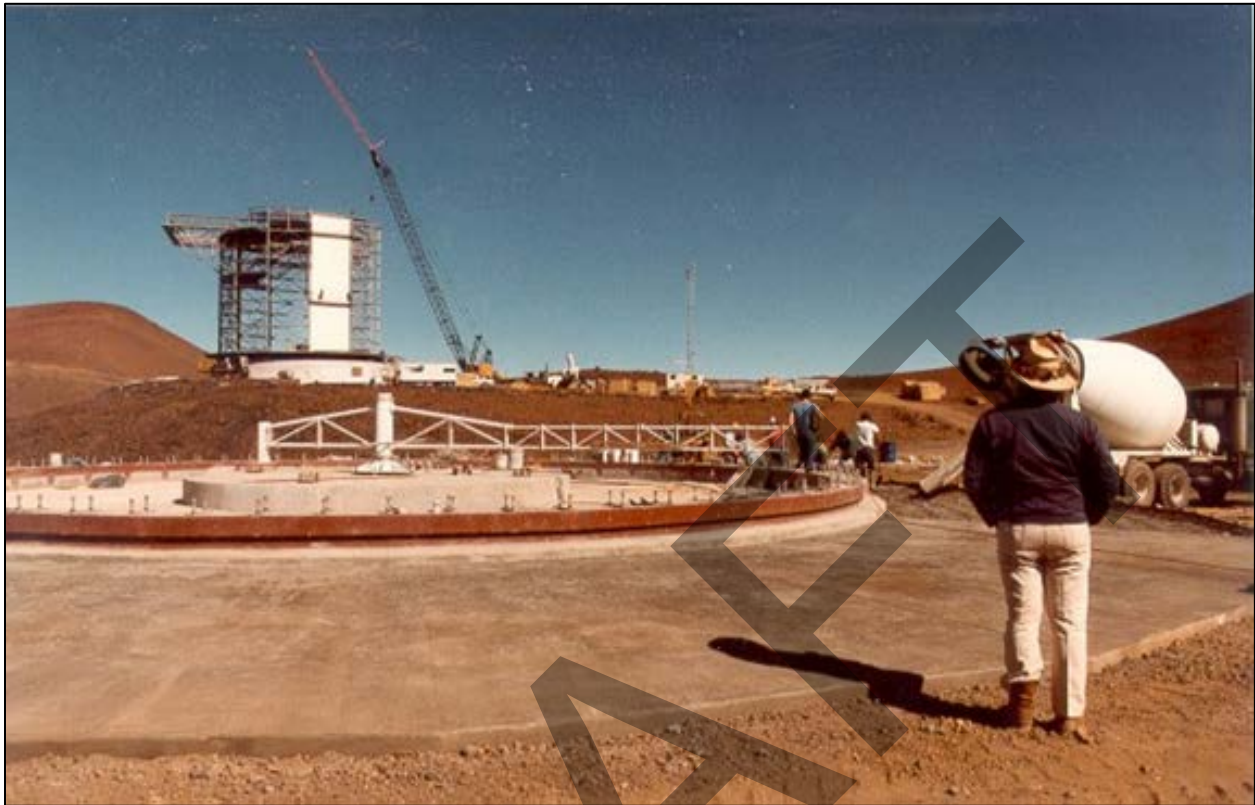
Figure 5-6: Photograph of CSO's Foundation During Construction

The reinforced concrete foundation will be broken or cut, removed from the ground, and placed in roll-off bins. The portions of the grounding grid near the CSO's foundation will be removed during this phase; construction drawings indicate that the grounding grid is roughly one foot below grade and, therefore, all within the fill material placed on the CSO Site during construction. All material removed will be designated as deconstruction waste material and will be removed from the CSO Site and transported to an approved landfill, with the exception of recyclable material such as copper piping or grounding mats, which will be transported to a designated recycling center.

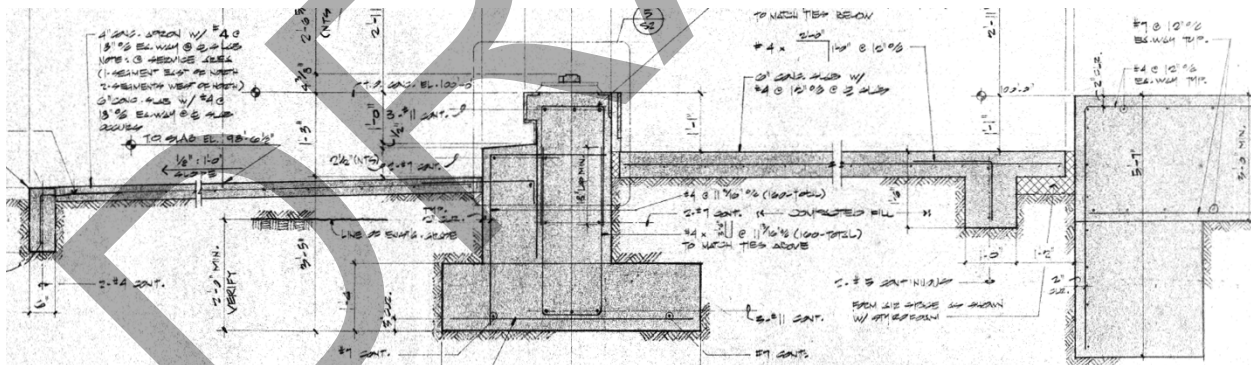
Figure 5-7: Section Drawing Illustrating a Portion of CSO's Foundation

Source: CSO Foundation Plan by H. Robert Hoggan & Associates dated 12/5/83.

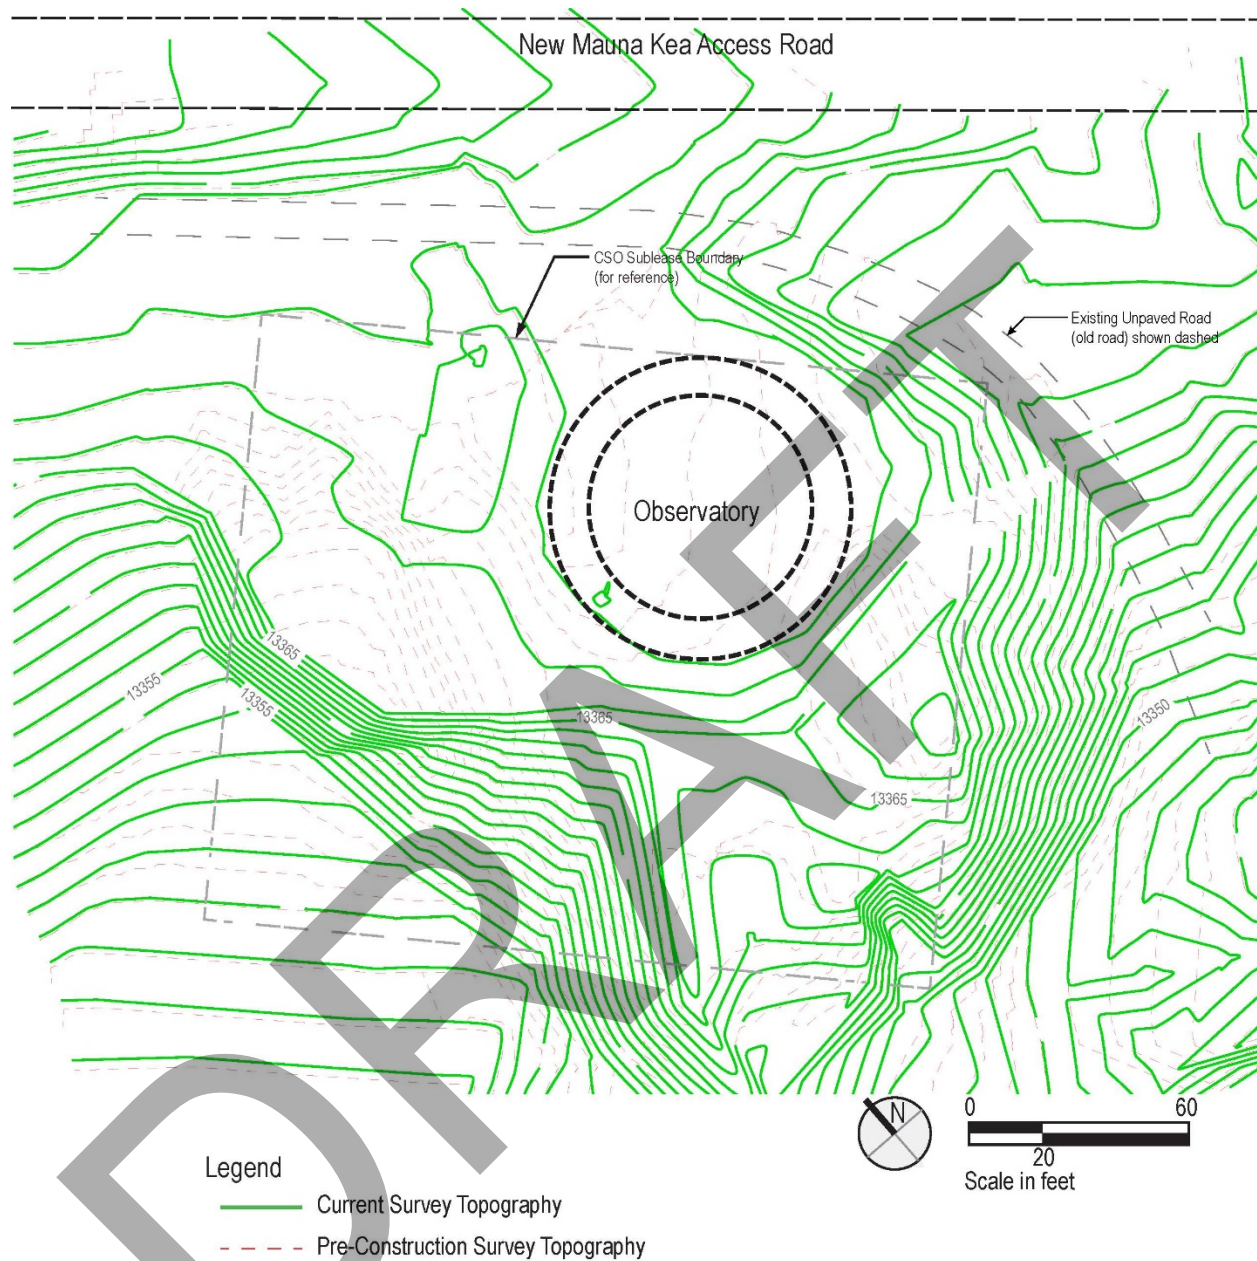
Figure 6-3: Comparison of Pre-Construction and 2016 Topographical Surveys

This figure reproduces information not legible in the 1982 pre-construction topographical conducted by Austin, Tsutsumi and Associates, Inc. Source: dlb & Associates (2016)

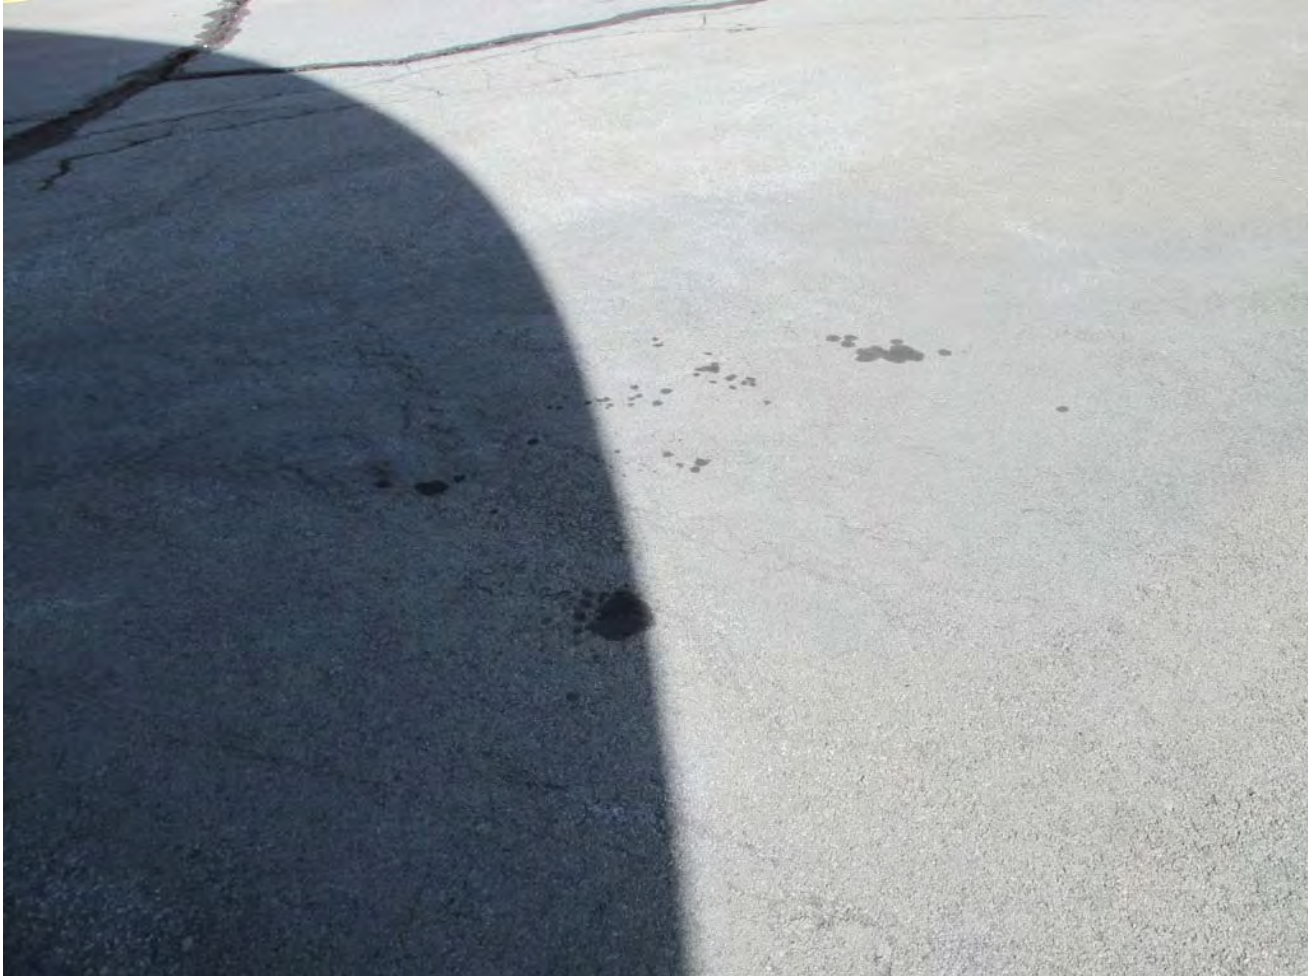
Photo 20

Stained Concrete at the Base of the Observatory

REC 1 Hydraulic Fluid Release. This finding is considered a recognized environmental condition because, despite the release being cleaned up to the satisfaction of the Department of Health there is a No Further Action status pending further soil testing under the slab after the decommissioning of the observatory.

The Phase I ESA recommends that soil samples be collected and analyzed for contaminants associated with hydraulic fluid to assess whether the spill has been fully remediated. The implementation of this recommendation by Caltech is discussed in Section 5.1.11.

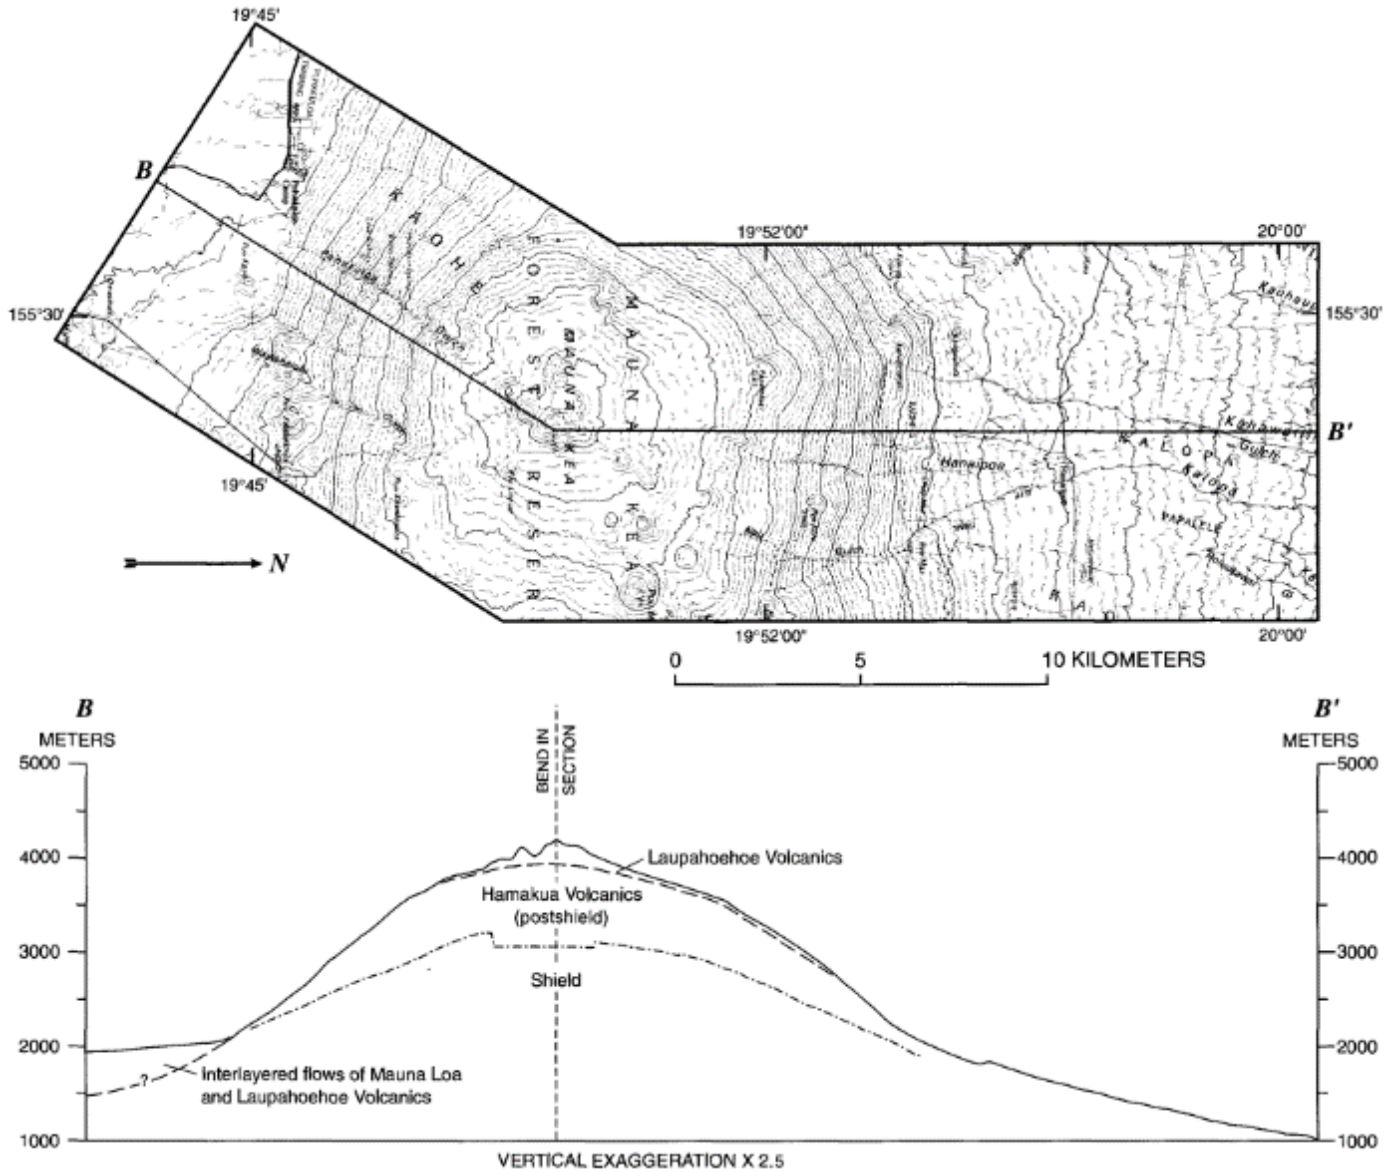
Figure 18. Cross-Section and Location Map of Maunakea (Wolfe et al., 1997).
